**Flood Control Project Maintenance
Levee Inspections****LMA District Cover Sheet****Spring 2016 Levee Inspection Results****Reclamation District No. 0307 Lisbon**

Spring 2016 Levee Inspection Results

Reclamation District No. 0307 Lisbon

| Waterway | | | Bank | Unit Miles |
|--|---|---|---|---|
| Unit No. 01 Sacramento River | | | Right | 6.56 |

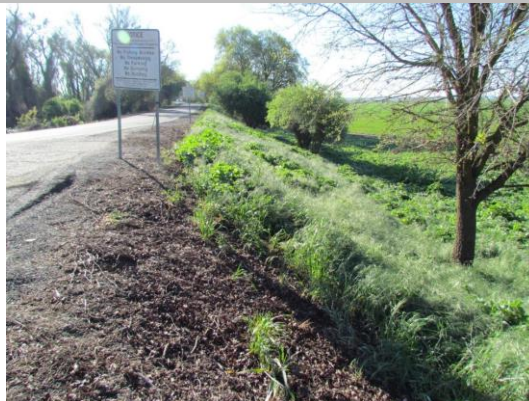
Photo 1 of 1 : SP_2016_RD0307_166_82_20160321_00094.jpg

Looking downstream from levee mile 0.00 landside shoulder.

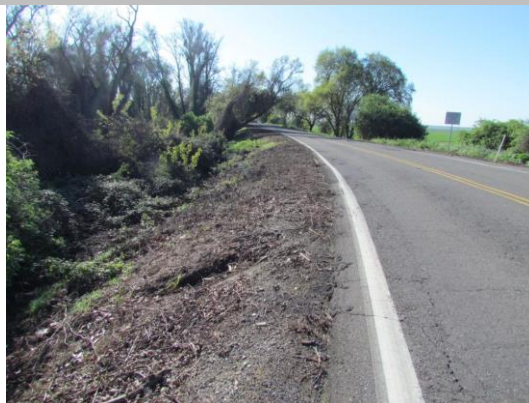
Photo 1 of 1 : SP_2016_RD0307_166_56_20160321_00093.jpg

Looking downstream from levee mile 0.00 waterside shoulder.

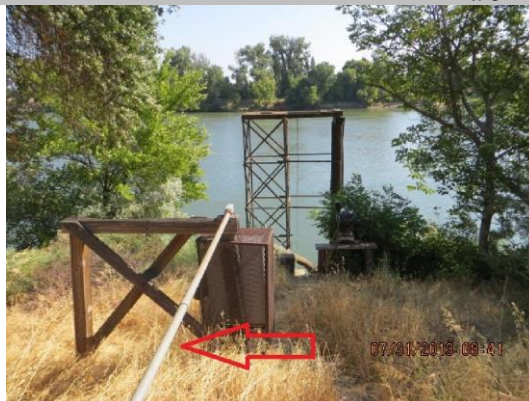
Photo 1 of 2 : UCIP_SP_2016_42934_28733.jpg

FS_ID:42934
DS_ID:21657
EP_NO: N/A
Repair Type: Urgent
Crossing Status: Found
UCIP Comments: Pipe heavily corroded and will likely need replacement if 15-inch pipe sleeved through it needs replacement. Annular space not grouted between two pipes.
FIELD_STRUCT_DESC: 20-inch steel irrigation pipe through the levee 16.7 feet below the crown. 15-inch pipe sleeved through this pipe. Pump missing from abandoned steel pier on WS toe. Walkway from shoulder to pier missing or abandoned. Originally included in the 1959 O&M manual.
FS Date: 7/31/2013

Abandoned wakway and metal pier on WS slope.

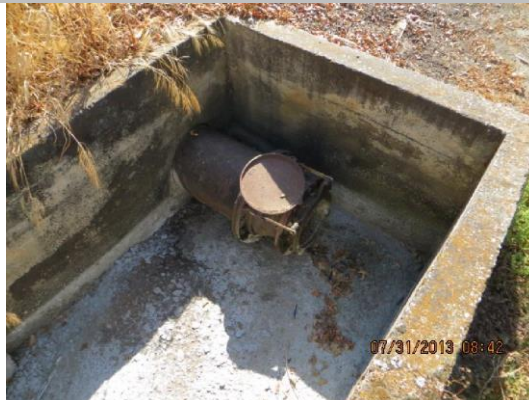
Photo 2 of 2 : UCIP_SP_2016_42934_28732.jpg

Pipe at outlet on LS toe.

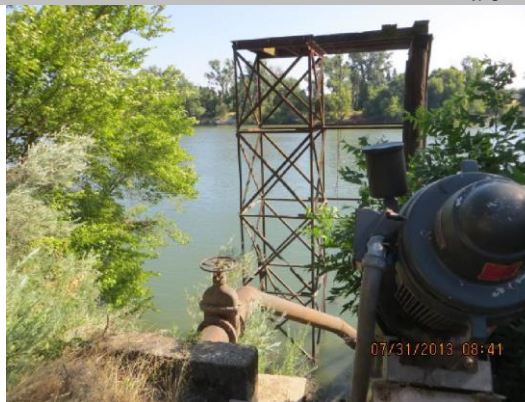
Photo 2 of 2 : UCIP_SP_2016_16743_28721.jpg

| FS_ID:16743 DS_ID:21656 EP_NO: N/A Repair Type: Urgent Crossing Status: Found UCIP Comments: Pipe heavily corroded at outlet on LS toe. Holes on bottom of pipe at outlet and internal circumference shows heavy exfoliation. Pipe failing internally. Recommend replacement or video inspection before continuing use. FIELD_STRUCT_DESC: 1 of 2: 15-inch steel irrigation pipe sleeved through 21-inch steel conduit, through the levee 16.7 feet below crown. Slant pump, gate valve, concrete headwall, electrical control pane, and abandoned pier on WS slope. Concrete U-shaped outlet with flap gate on LS toe. Service pole on the landward slope with anchor. FS Date: 7/31/2013 9:44:32 AM | | | | | |

Pipe, gate valve, pump, and abandoned metal pier on WS slope.

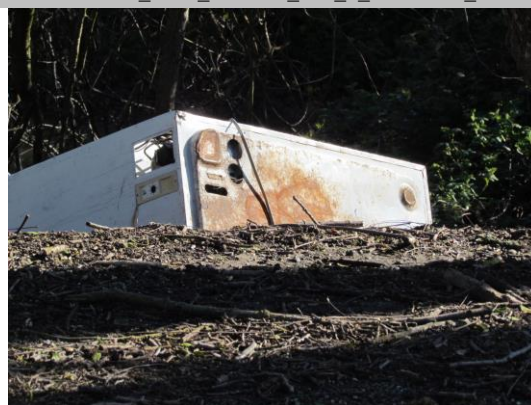
Photo 1 of 1 : SP_2016_RD0307_166_5_20160321_00095.jpg

Discarded appliance on the waterside slope.

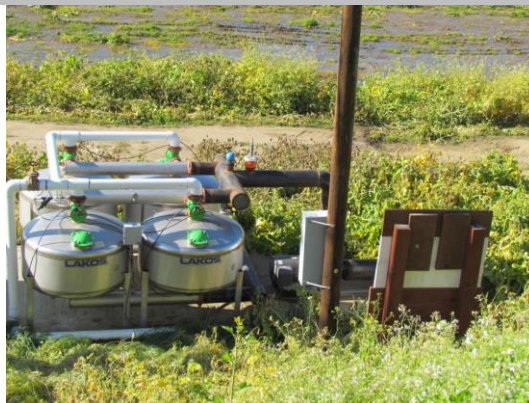
Photo 1 of 1 : SP_2016_RD0307_166_61_20160321_00096.jpg

Sand filter, power pole and panel box within the 10-foot easement.

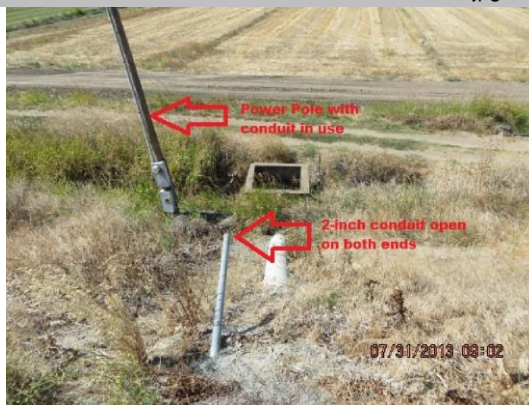
Photo 1 of 2 : UCIP_SP_2016_17103_29202.jpg

| FS_ID:17103 DS_ID:24014 EP_NO: 18229 Repair Type: Non-Urgent Crossing Status: Found UCIP Comments: Pipe open on both ends. Need to install caps. FIELD_STRUCT_DESC: 2 of 2: 2-inch galvanized iron pipe through the levee 2.0 feet below the crown (Permit No. 18229, 2007). FS Date: 7/31/2013 | | | | | |

Conduit visible 2-feet below the crown on the LS shoulder.

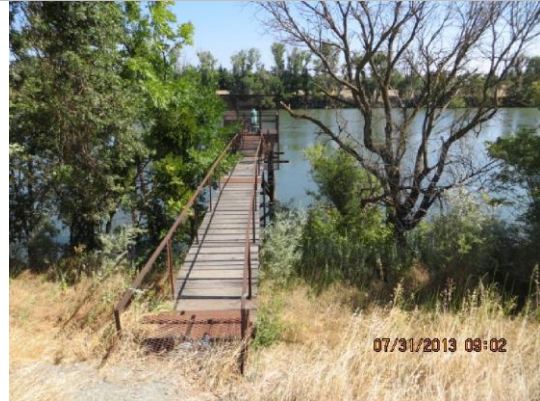
Photo 2 of 2 : UCIP_SP_2016_17103_29201.jpg

Conduit visible under first step of walkway to pump on WS shoulder.

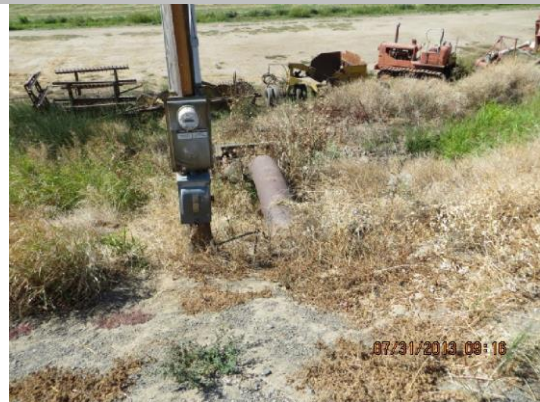
Photo 1 of 2 : UCIP_SP_2016_16764_28764.jpg

| FS_ID:16764 DS_ID:21659 EP_NO: 8012 Repair Type: Non-Urgent Crossing Status: Found UCIP Comments: Pipe rusted through at outlet on LS of shutoff valve. This may be good indicator or corrosion throughout pipe. This is a good candidate for video inspection. FIELD_STRUCT_DESC: 1 of 2: 20-inch steel pipe through levee 7.4 feet below crown. Walkway from the waterward shoulder to pump on pile structure in stream. Distribution box and gate valve at toe of landward slope. Service pole on the landward side (Permit No. 8012, 1972). Originally included in the 1959 O&M manual. FS Date: 7/31/2013 | | | | | |

Pipe and JP/meter on LS slope.

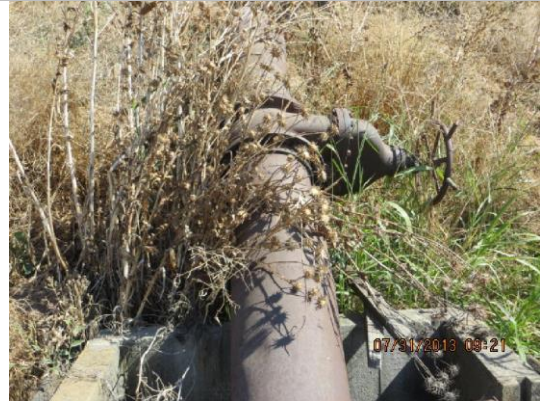
Photo 2 of 2 : UCIP_SP_2016_16764_28763.jpg

| FS_ID:16764 DS_ID:21659 EP_NO: 8012 Repair Type: Non-Urgent Crossing Status: Found UCIP Comments: Pipe rusted through at outlet on LS of shutoff valve. This may be good indicator or corrosion throughout pipe. This is a good candidate for video inspection. FIELD_STRUCT_DESC: 1 of 2: 20-inch steel pipe through levee 7.4 feet below crown. Walkway from the waterward shoulder to pump on pile structure in stream. Distribution box and gate valve at toe of landward slope. Service pole on the landward side (Permit No. 8012, 1972). Originally included in the 1959 O&M manual. FS Date: 7/31/2013 | | | | | |

Pipe, gate valve, and concrete distribution box on LS toe.

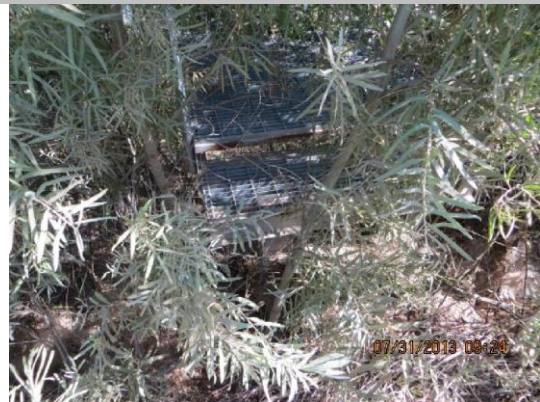
Photo 1 of 2 : UCIP_SP_2016_16766_28769.jpg

Metal walkway visible in brush on WS slope.

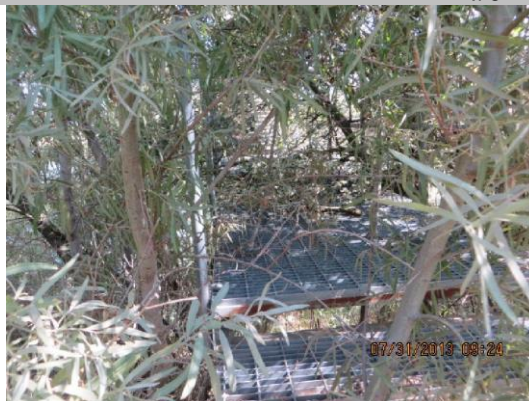
Photo 2 of 2 : UCIP_SP_2016_16766_28768.jpg

Metal walkway visible in brush on WS slope.

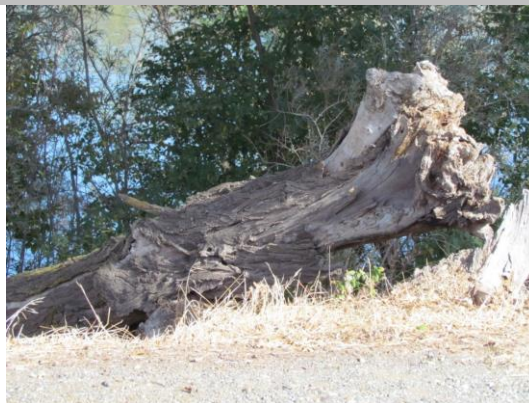
Photo 1 of 1 : SP_2016_RD0307_166_9_20160223_00004.jpg

This tree needs to be removed from the waterside slope.

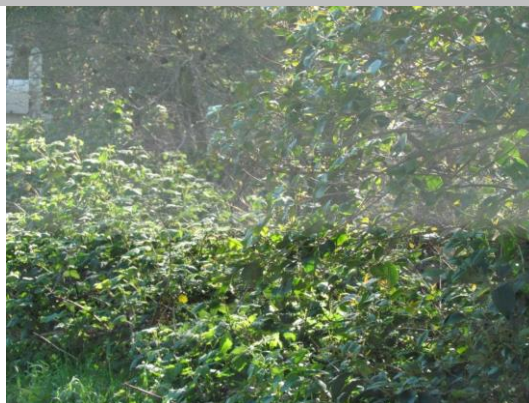
Photo 1 of 1 : SP_2016_RD0307_166_69_20160321_00097.jpg

Looking downstream from levee miles 1.59-1.66 slope covered in berry vines.

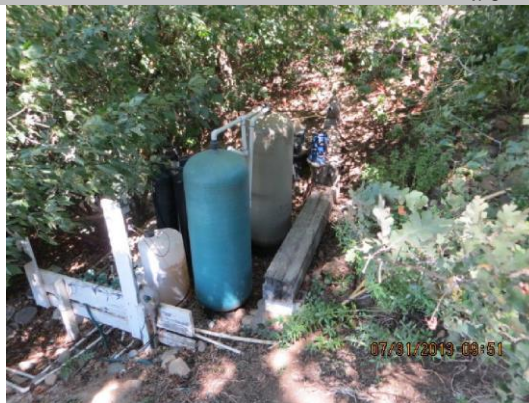
Photo 1 of 2 : UCIP_SP_2016_17105_29207.jpg

FS_ID:17105
DS_ID:24017
EP_NO: N/A
Repair Type: Non-Urgent
Crossing Status: Found
UCIP Comments: No permit identified for crossing or boat dock/steel ramp.
FIELD_STRUCT_DESC: 2 of 2: 1.5-inch PVC pipe through the levee 2-feet below the crown. Metal walkway/pier on WS slope. Possible pump on LS slope with filter tanks.
FS Date: 7/31/2013

Possible pump and filter station on LS slope.

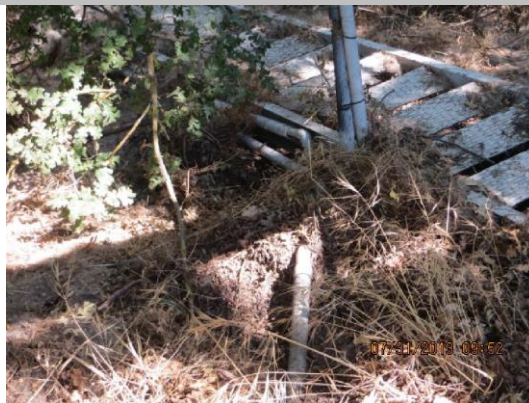
Photo 2 of 2 : UCIP_SP_2016_17105_29206.jpg

Pipes visible on WS shoulder at steel walkway.

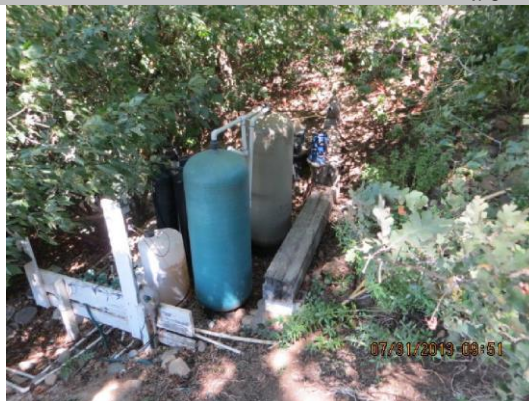
Photo 1 of 2 : UCIP_SP_2016_17106_29210.jpg

FS_ID:17106
DS_ID:24016
EP_NO: N/A
Repair Type: Non-Urgent
Crossing Status: Found
UCIP Comments: No permit identified for this crossing.
FIELD_STRUCT_DESC: 1 of 2: 1.5-inch PVC pipe through the levee 2-feet below the crown. Metal walkway/pier on WS slope. Possible pump, Filter, and tanks on LS slope.
FS Date: 7/31/2013

Possible pump and filter plant on LS slope.

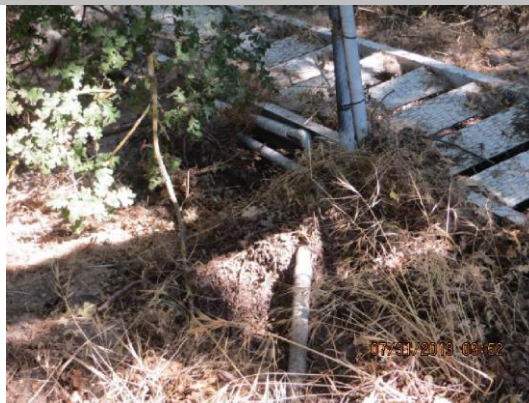
Photo 2 of 2 : UCIP_SP_2016_17106_29209.jpg

Pipes visible on WS shoulder at metal ramp.

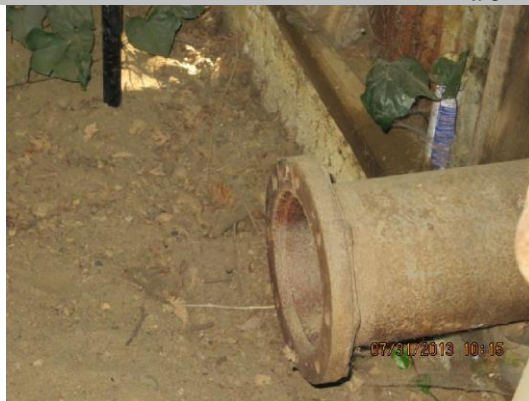
Photo 1 of 2 : UCIP_SP_2016_16805_28806.jpg

| FS_ID:16805 DS_ID:21663 EP_NO: 8016 Repair Type: Non-Urgent Crossing Status: Indicator Found UCIP Comments: Needs to be abandoned properly. FIELD_STRUCT_DESC: *Abandoned* 8-inch iron pipe through the levee 15.7 feet below the crown. No connection in pump house on the LS toe, but 8-inch outlet pipe remains at connection from pumphouse to concrete standpipe. (Permit No. 8016, 1972). Pipe capped at both ends according to Permit No. 18209 for replacement pipe. Originally included in the 1959 O&M manual. FS Date: 7/31/2013 | | | | | |

Remnants of abandoned pipe visible in pumphouse on LS toe.

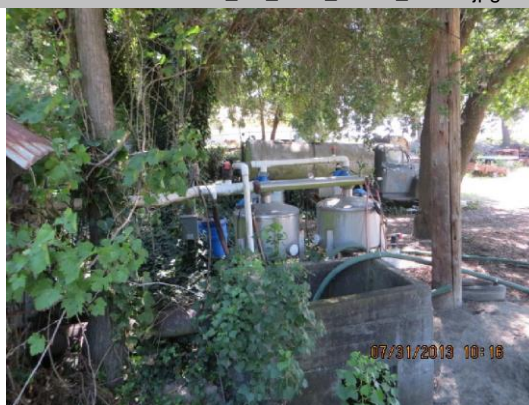
Photo 2 of 2 : UCIP_SP_2016_16805_28805.jpg

Concrete distribution box at LS toe.

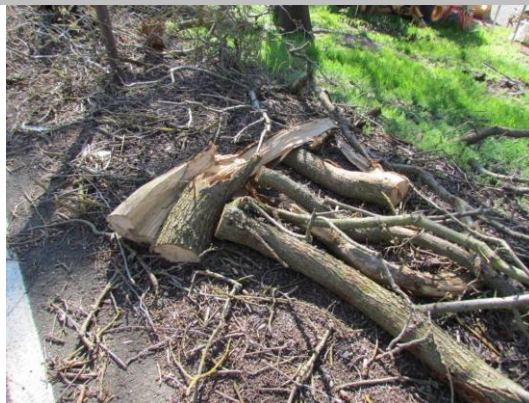
Photo 1 of 3 : SP_2016_RD0307_166_73_20160321_00098.jpg

Looking downstream from levee mile 1.86 cut up fallen tree on shoulder.

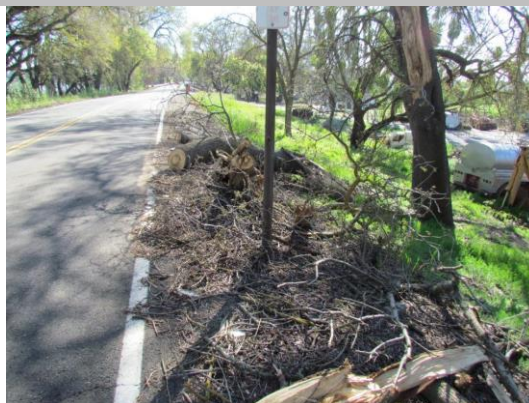
Photo 2 of 3 : SP_2016_RD0307_166_73_20160321_00102.jpg

Looking downstream toward levee mile 1.87 fallen tree on shoulder.

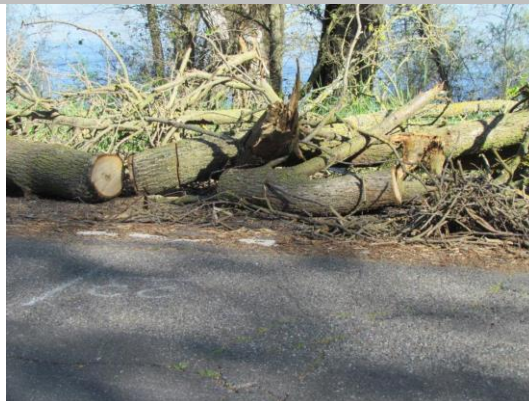
Photo 3 of 3 : SP_2016_RD0307_166_73_20160321_00103.jpg

Waterside shoulder levee mile 1.86 more of the cut up oak.

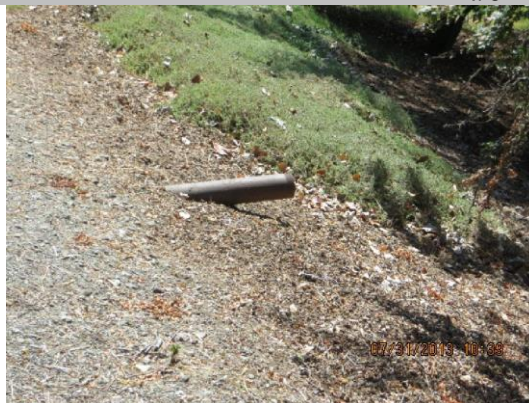
Photo 1 of 2 : UCIP_SP_2016_22709_38412.jpg

| FS_ID:22709 DS_ID:21665 EP_NO: N/A Repair Type: Non-Urgent Crossing Status: Found UCIP Comments: Pipe abandoned and should be done so properly. FIELD_STRUCT_DESC: 5-inch steel irrigation pipe through the levee 2.0-feet below the crown. Pipe open on both ends. Originally included in the 1959 O&M manual. FS Date: 7/31/2013 | | | | | |

Pipe visible on LS shoulder.

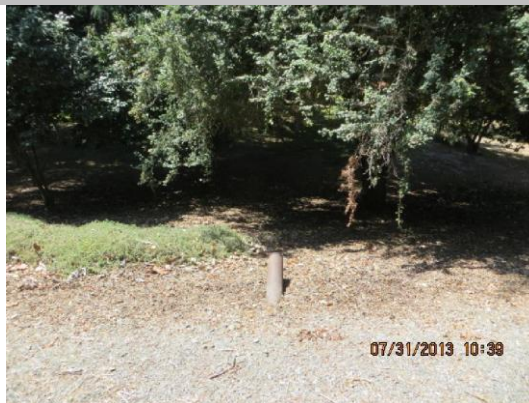
Photo 2 of 2 : UCIP_SP_2016_22709_38411.jpg

Pipe visible on LS shoulder.

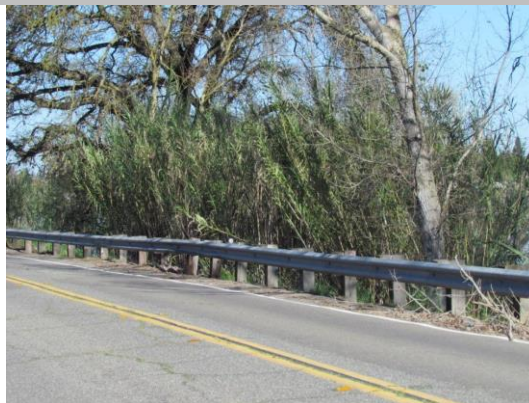
Photo 1 of 1 : SP_2016_RD0307_166_74_20160321_00104.jpg

Bamboo present on the waterside shoulder and slope.

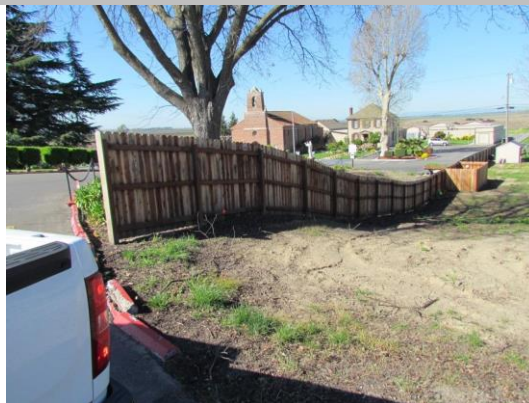
Photo 1 of 1 : SP_2016_RD0307_166_79_20160321_00105.jpg

Looking down the landside slope and shoulder of levee mile 3.19 new replacement of a solid wall wooden fence.

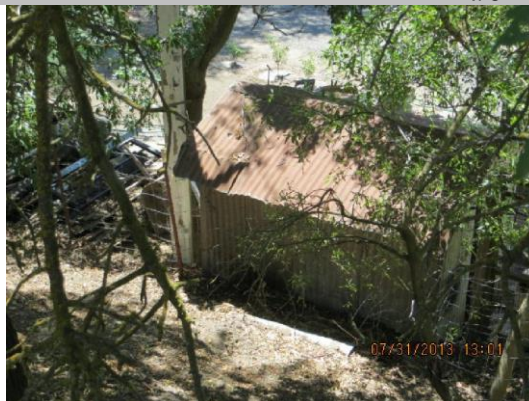
Photo 1 of 2 : UCIP_SP_2016_16843_28881.jpg

Pumphouse on LS toe. No access due to fence along toe.

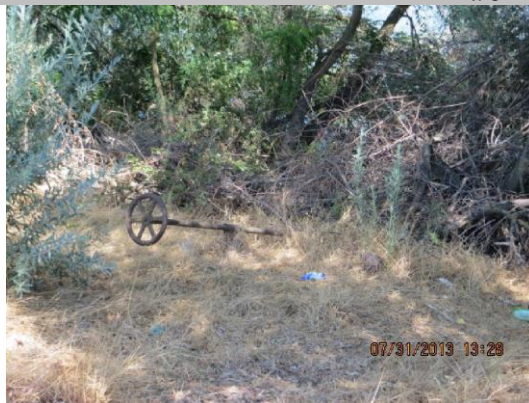
Photo 1 of 2 : UCIP_SP_2016_16923_28978.jpg

| FS_ID:16923 DS_ID:21679 EP_NO: N/A Repair Type: Non-Urgent Crossing Status: Found UCIP Comments: Gate valve does not function on WS slope. Pipe and pump appear to be abandoned and should be done so properly. FIELD_STRUCT_DESC: 7-inch steel irrigation pipe through the levee 14.7 feet below the crown. Pump in pumphouse on LS toe. Gate valve on the WS slope and at pumphouse on the LS toe. Air vent on pipe at WS toe near waterline. Originally included in the 1959 O&M manual. FS Date: 7/31/2013 | | | | | |

Gate valve actuator on WS slope.

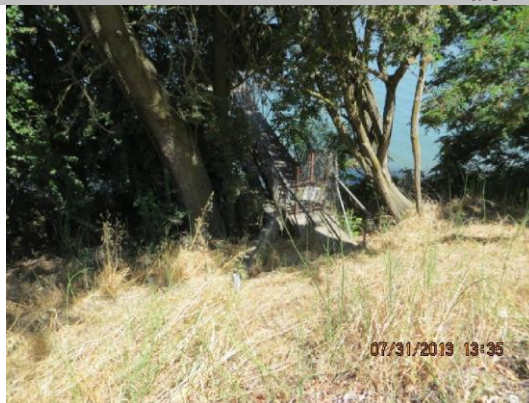
Photo 1 of 2 : UCIP_SP_2016_16924_28982.jpg

| FS_ID:16924 DS_ID:21680 EP_NO: 8030 Repair Type: Non-Urgent Crossing Status: Found UCIP Comments: Pipe not visible on LS slope or toe due to excessive vegetation. Vegetation should be cleared from pipe. FIELD_STRUCT_DESC: 1 of 2: 12-inch steel irrigation pipe through the levee 6-feet below the crown. Walkway on WS slope to a pump on a pile structure in the stream. JP and meter on LS toe. Pipe appears to cross levee at an angle. (Permit No. 8030, 1972). Included in the 1959 O&M manual. FS Date: 7/31/2013 | | | | | |

Pipe and walkway visible on WS slope.

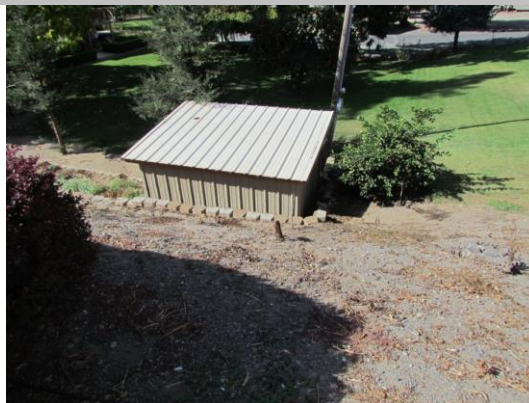
Photo 1 of 1 : SP_2016_RD0307_166_26_20160223_00007.jpg

This pump house was built without CVFPB Permit.

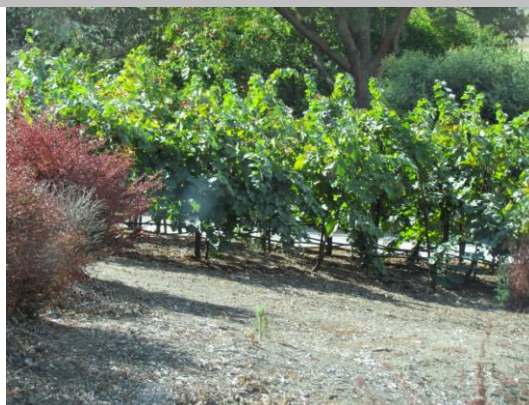
Photo 1 of 1 : SP_2016_RD0307_166_27_20160223_00008.jpg

Unwanted grapes placed on levee slope, these grapes has been reported to both district and CVFPB. No permit.

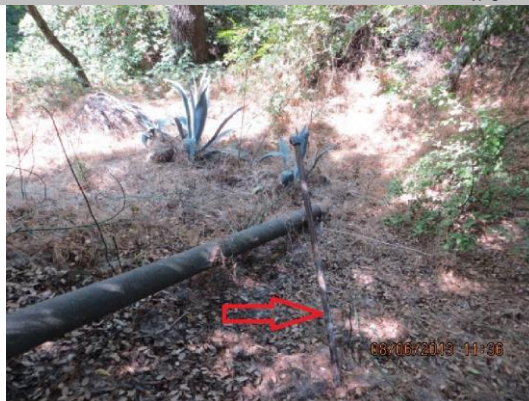
Photo 1 of 1 : UCIP_SP_2016_22672_38296.jpg

Abandoned electrical conduit next to pipe on LS slope.

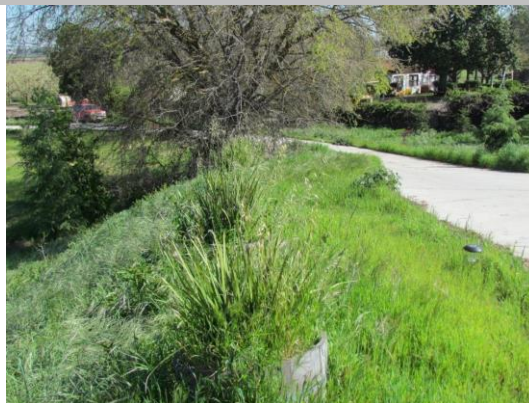
Photo 1 of 3 : SP_2016_RD0307_166_28_20160321_00110.jpg

Looking back upstream at the planters placed on the landward shoulder and ramp.

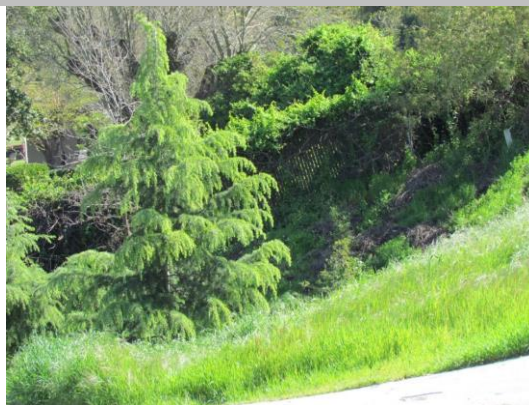
Photo 2 of 3 : SP_2016_RD0307_166_28_20160321_00111.jpg

Looking upstream landside slope and toe trees planted on the levee section.

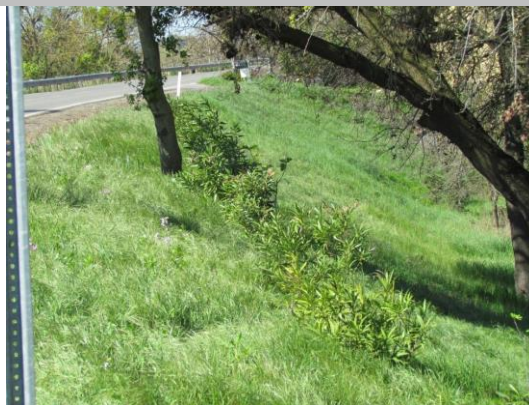
Photo 3 of 3 : SP_2016_RD0307_166_28_20160321_00106.jpg

Looking downstream from levee mile 5.33 landward at small oleander trees planted along the slope.

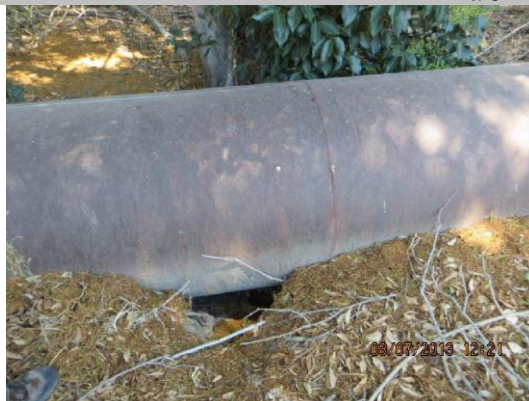
Photo 2 of 2 : UCIP_SP_2016_17404_29503.jpg

Animal activity/burrows under pipe on LS at various locations.
